THE GREAT ALASKA EARTHQUAKE

Volume II

Illustrations and Maps

TECHNICAL REPORT NO. AFWL-TR-65-92, Vol II

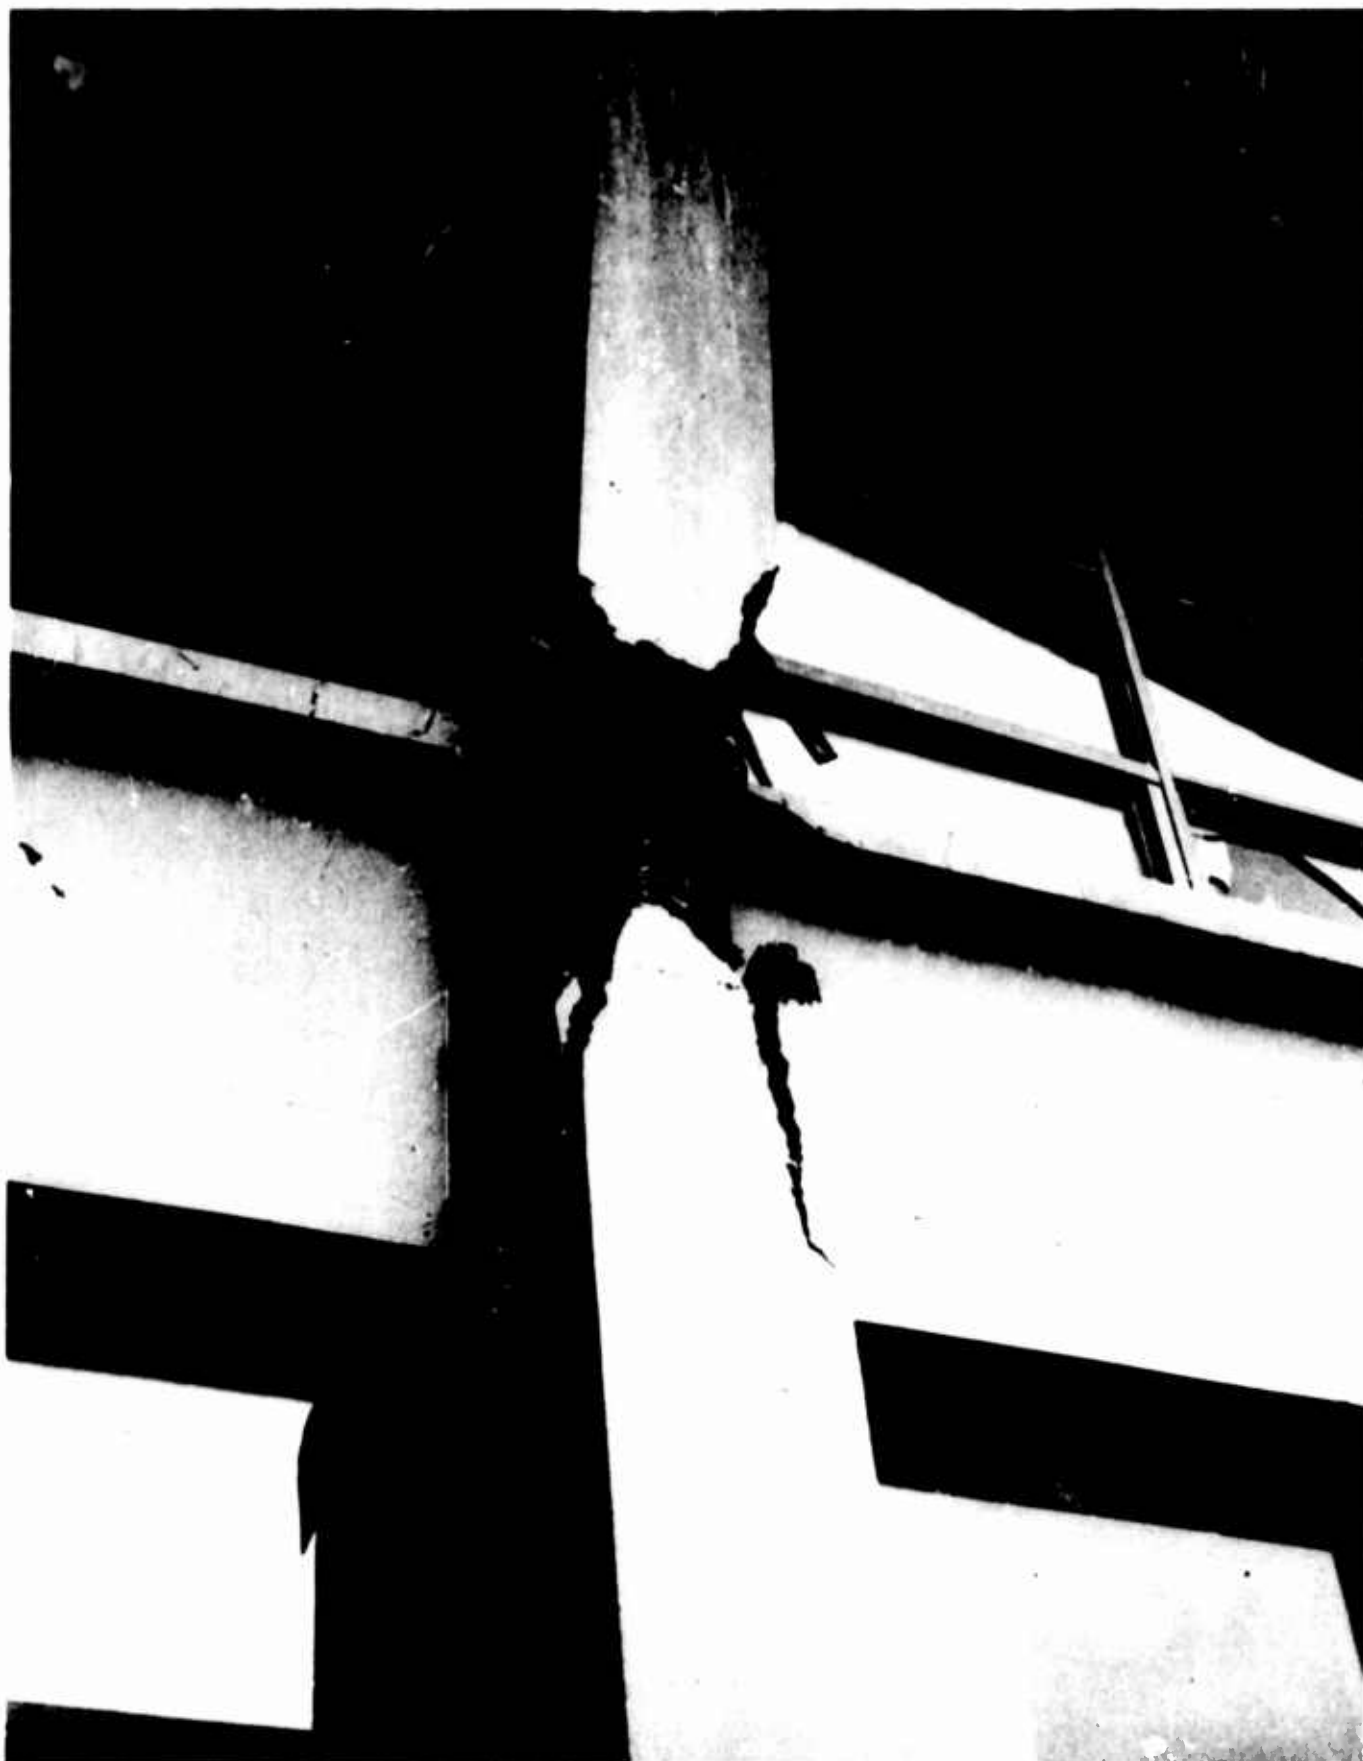
Figure 176. West Anchorage High School
(Closeup of damaged column shown in figure 174)

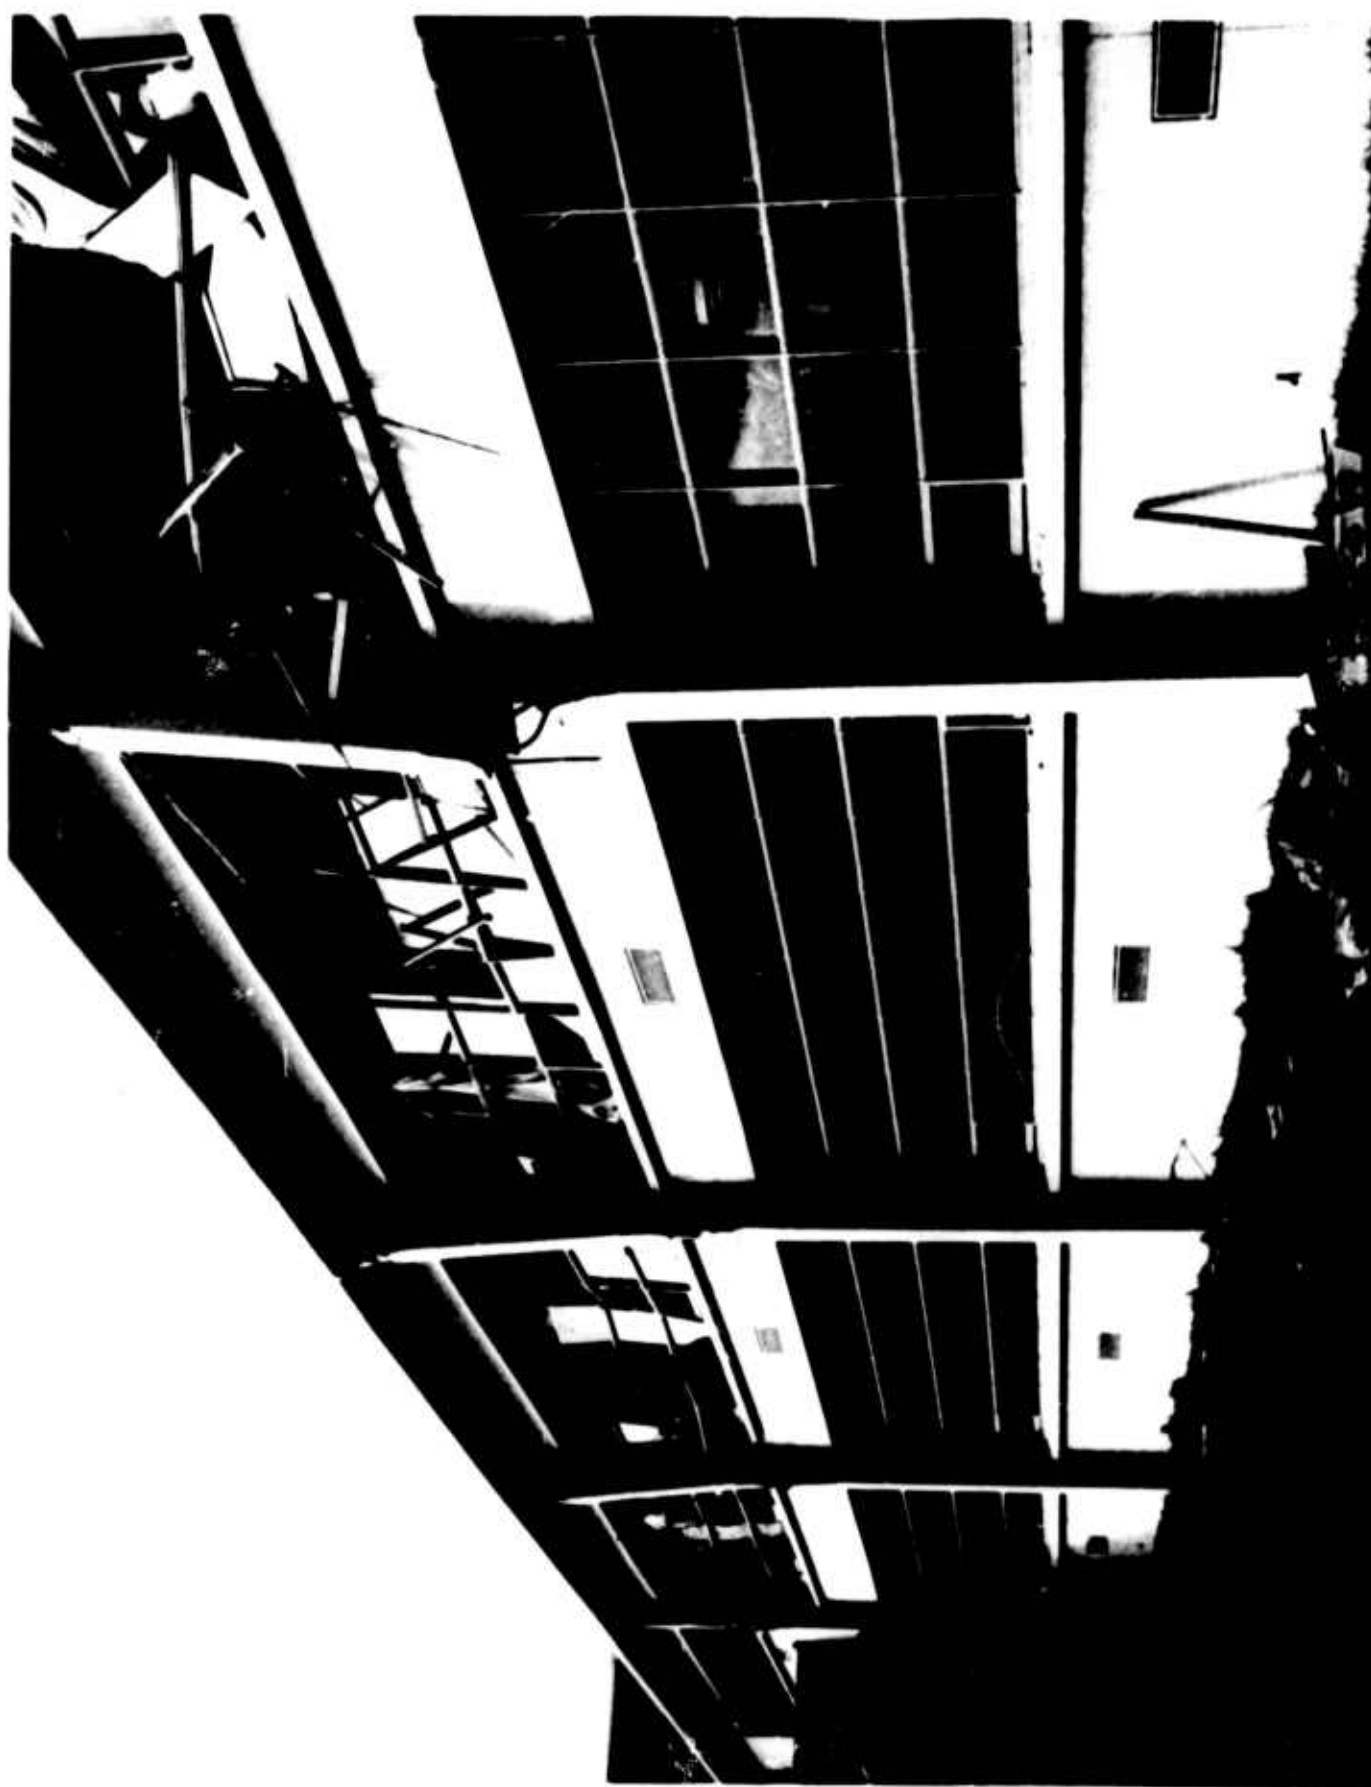
Figure 179. West Anchorage High School (Damage to second-story columns in south wall of wing B)

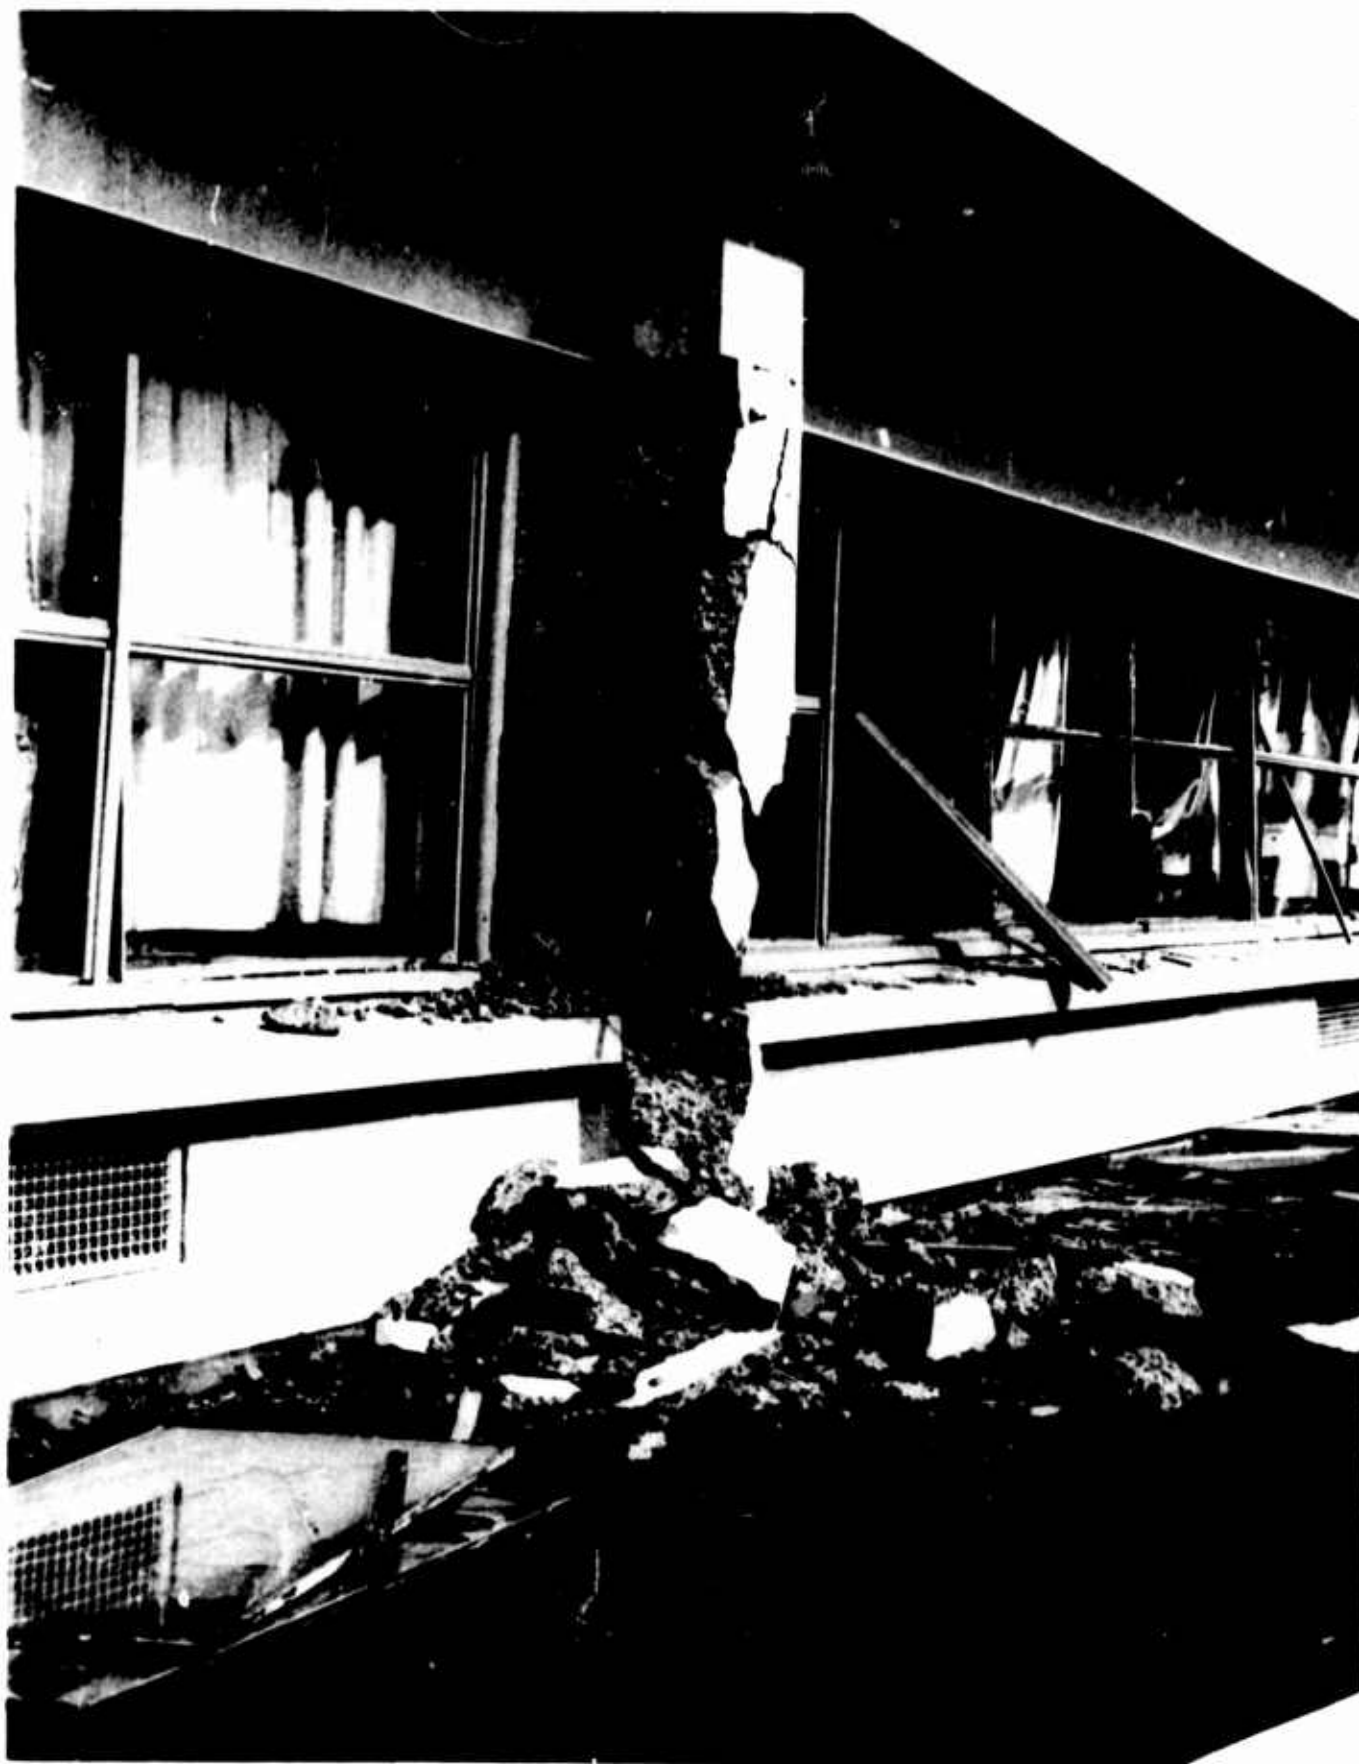
Figure 182. West Anchorage High School
(Damage to short second-story column in south wall of wing B
above the cafeteria was not prevented by light horizontal ties)

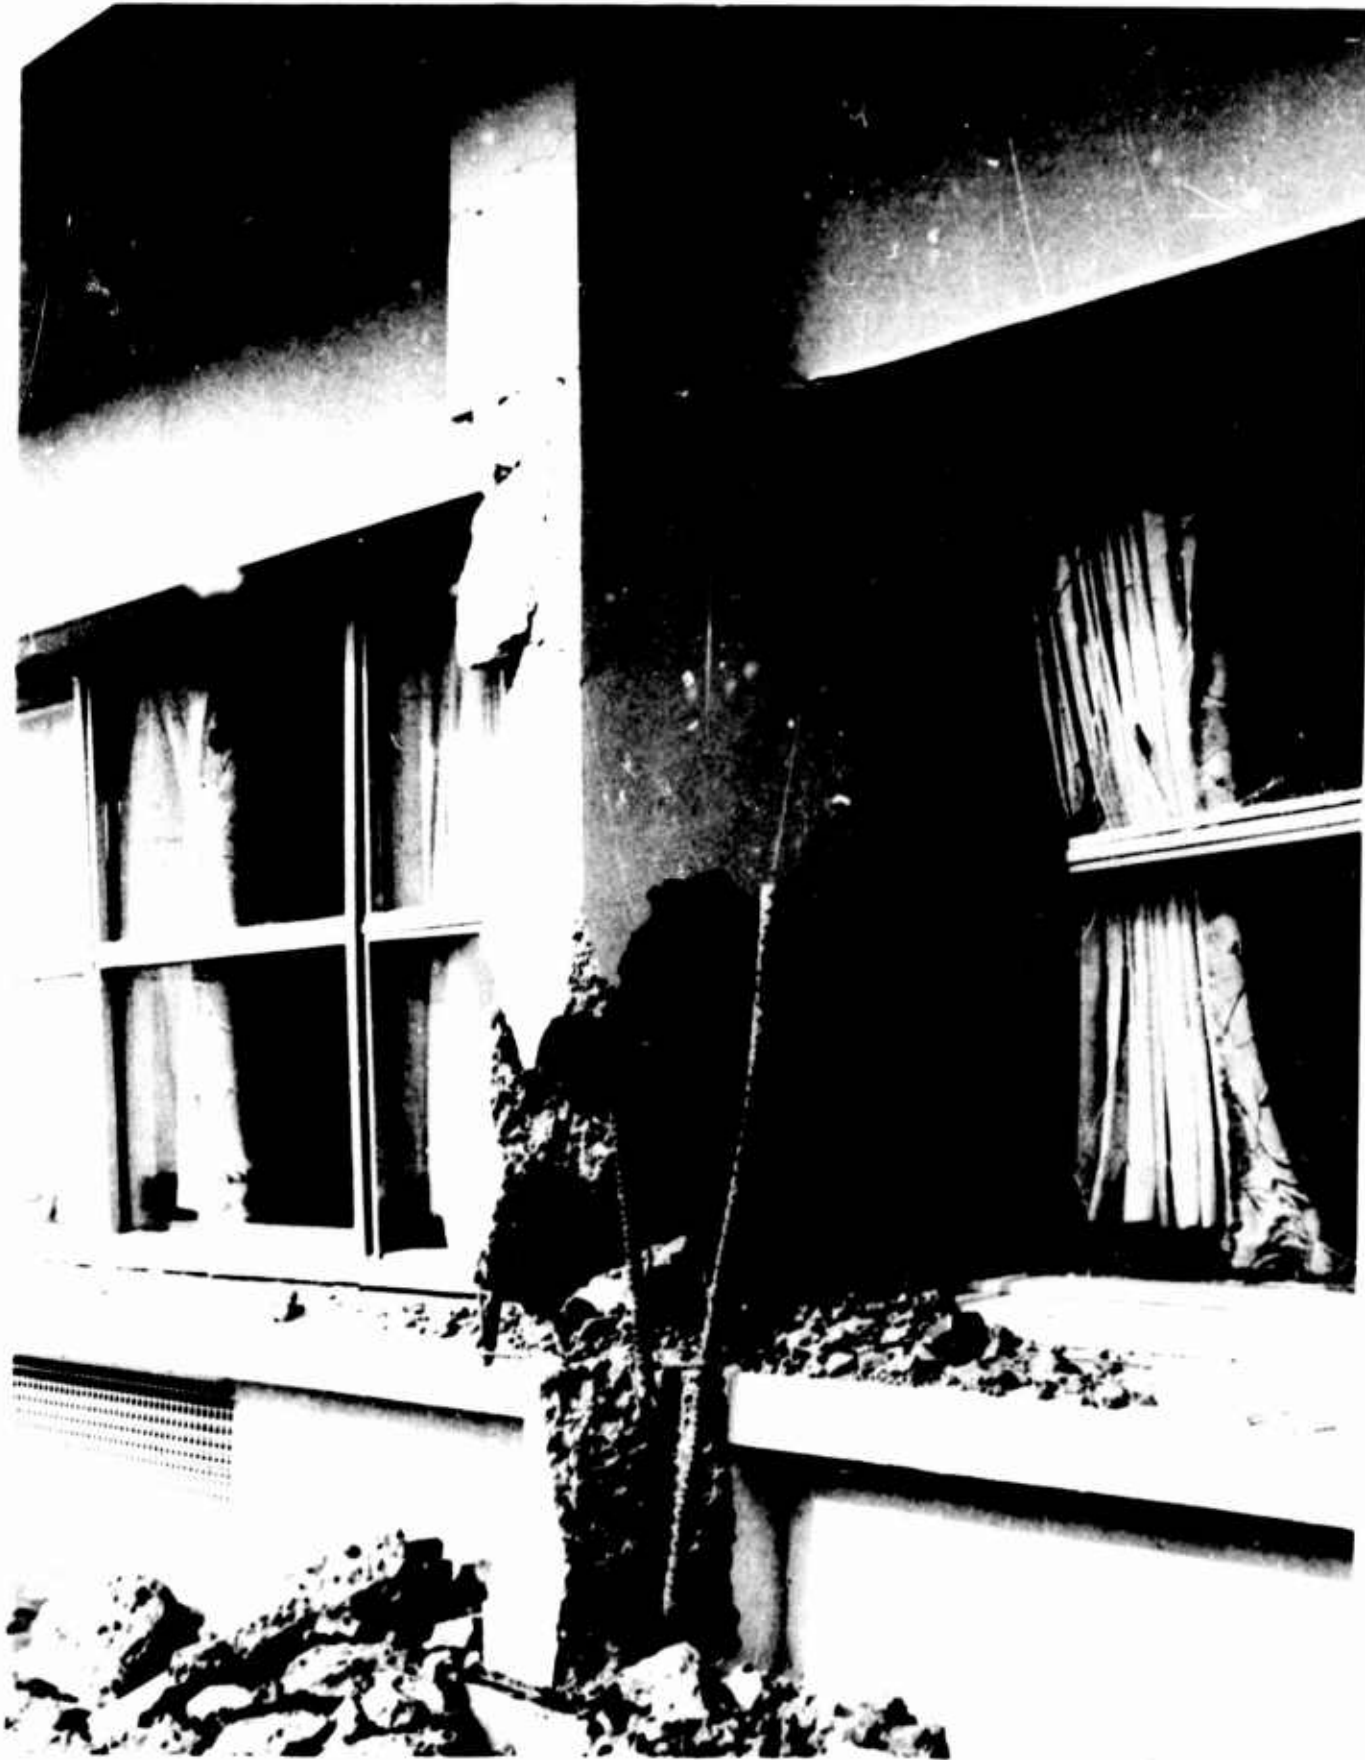
Figure 183. West Anchorage High School
(The other side of the column shown in figure 182)

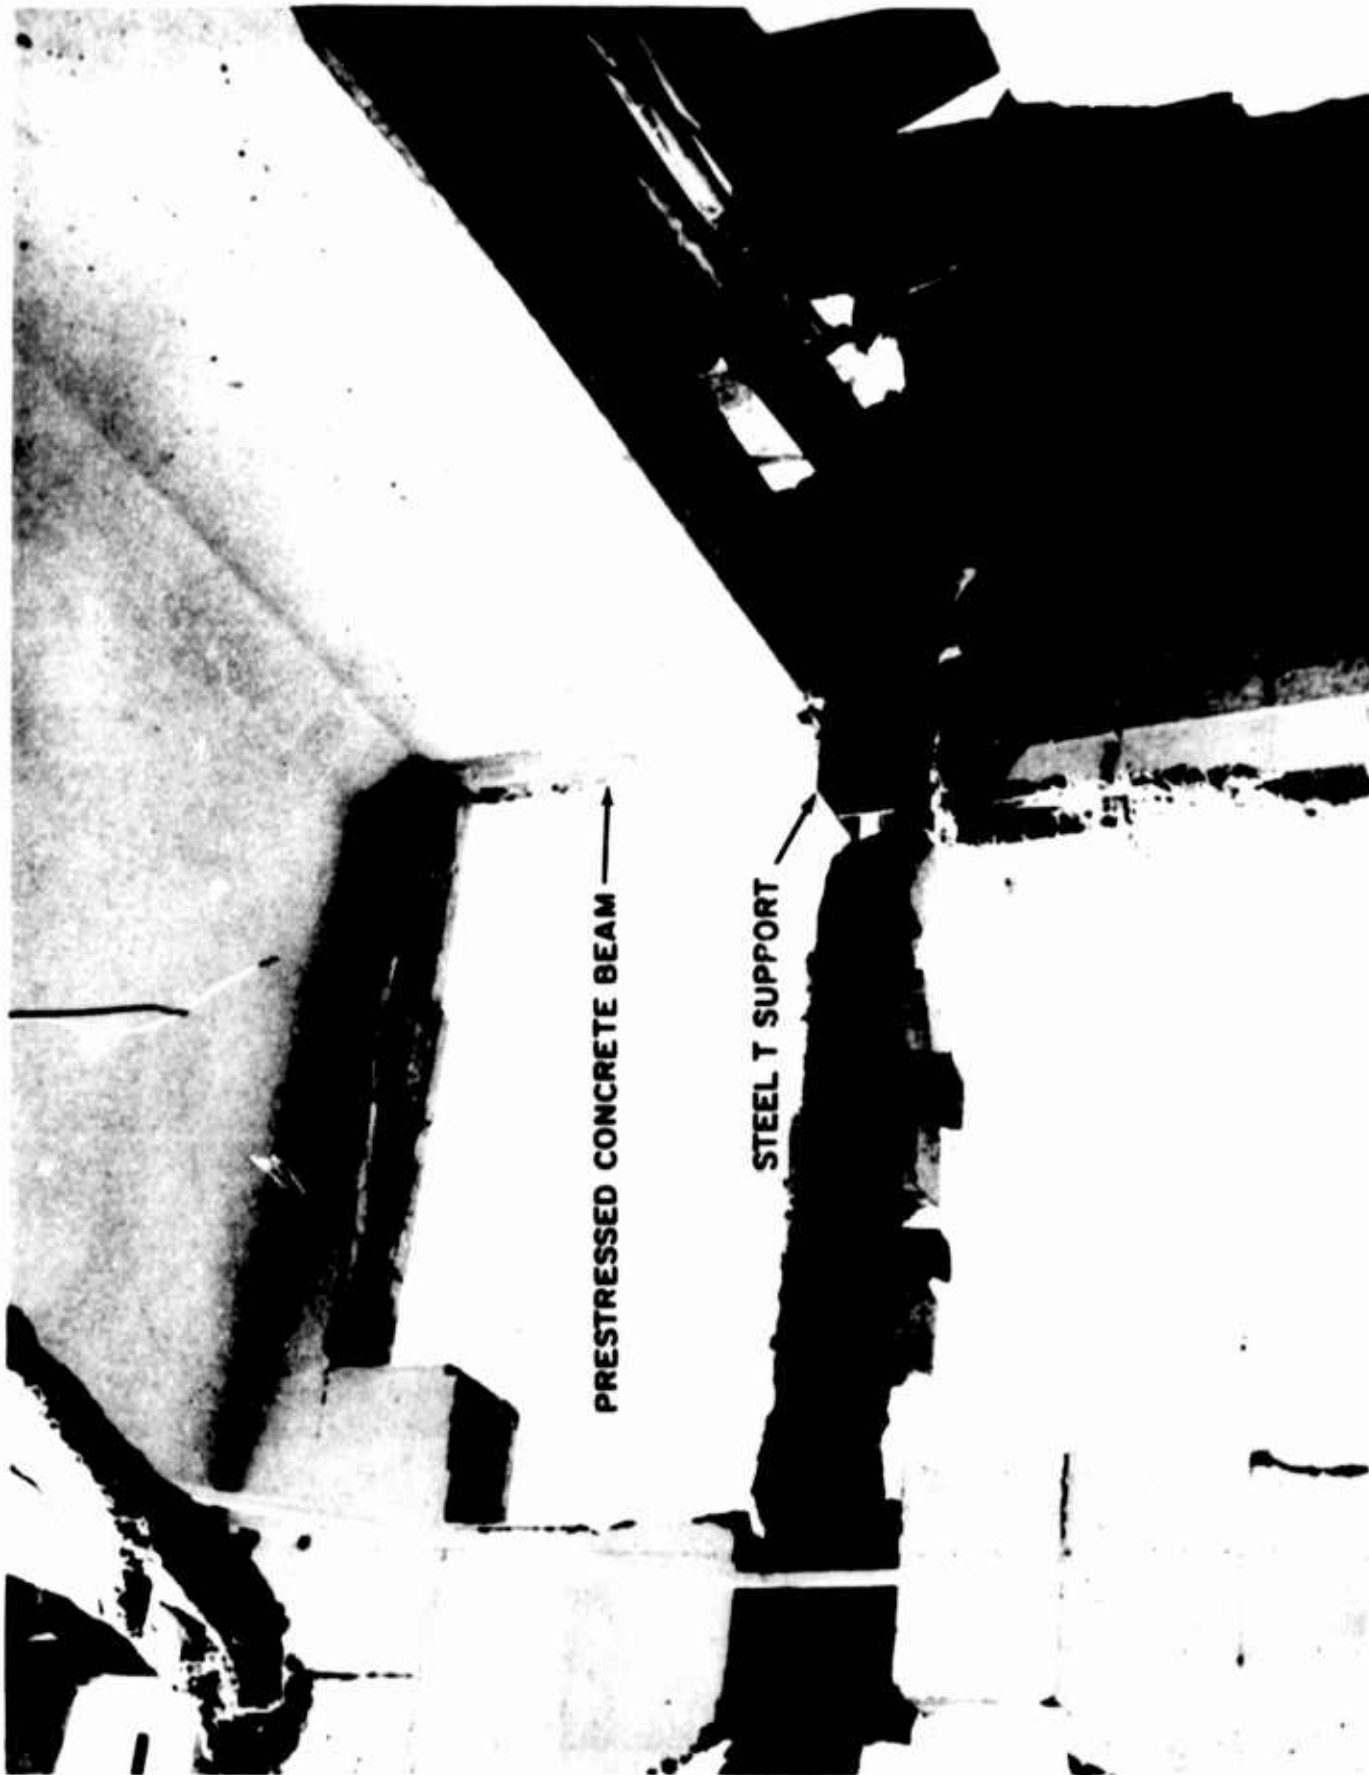
Figure 199. Fifth Avenue Chrysler Center (Closeup of end connection of prestressed T-roof beam)

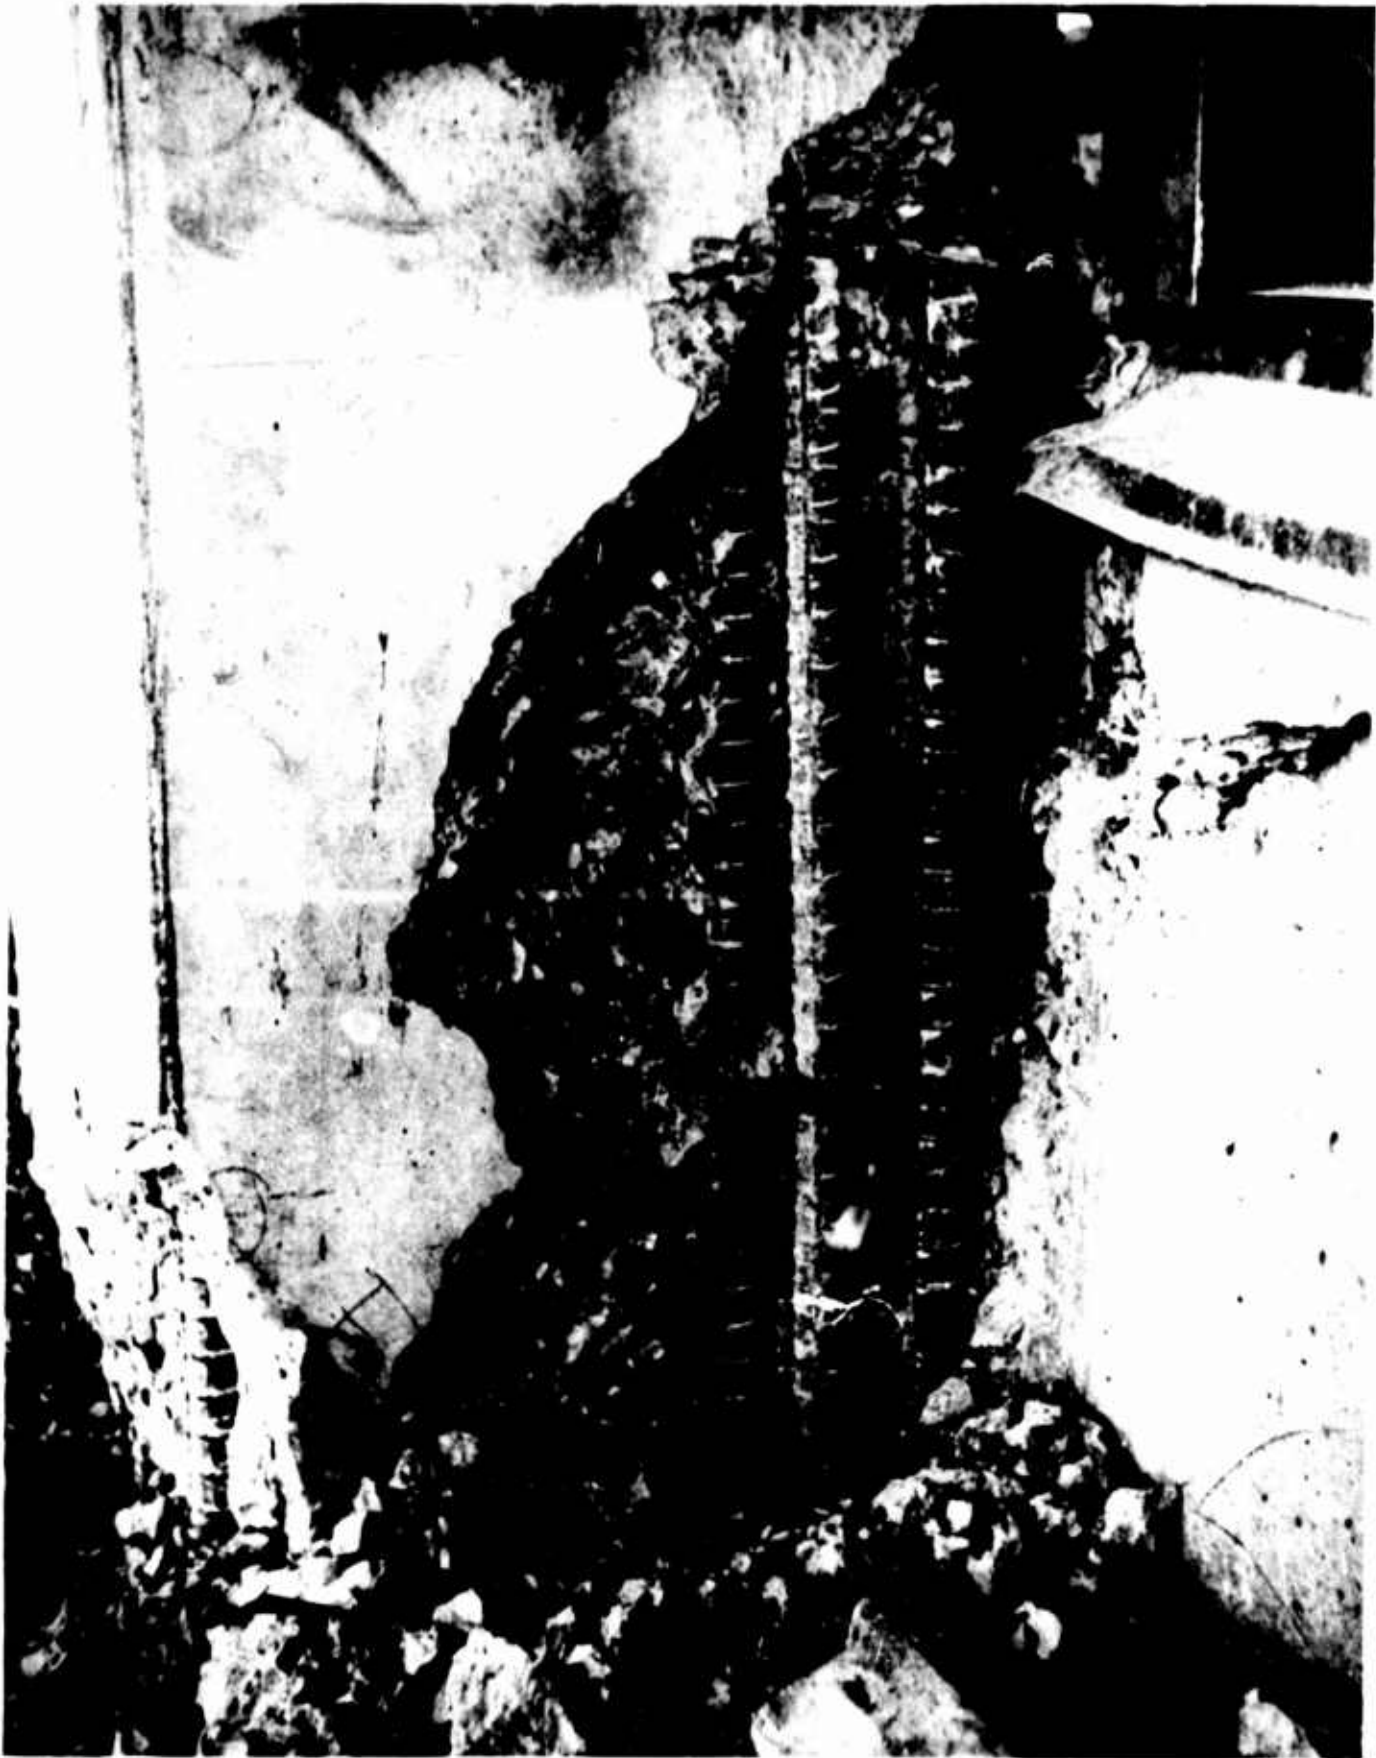
Figure 210. Alaska Sales and Service Building
(Spalling at the base of a heavy T-column along the north side of the structure)

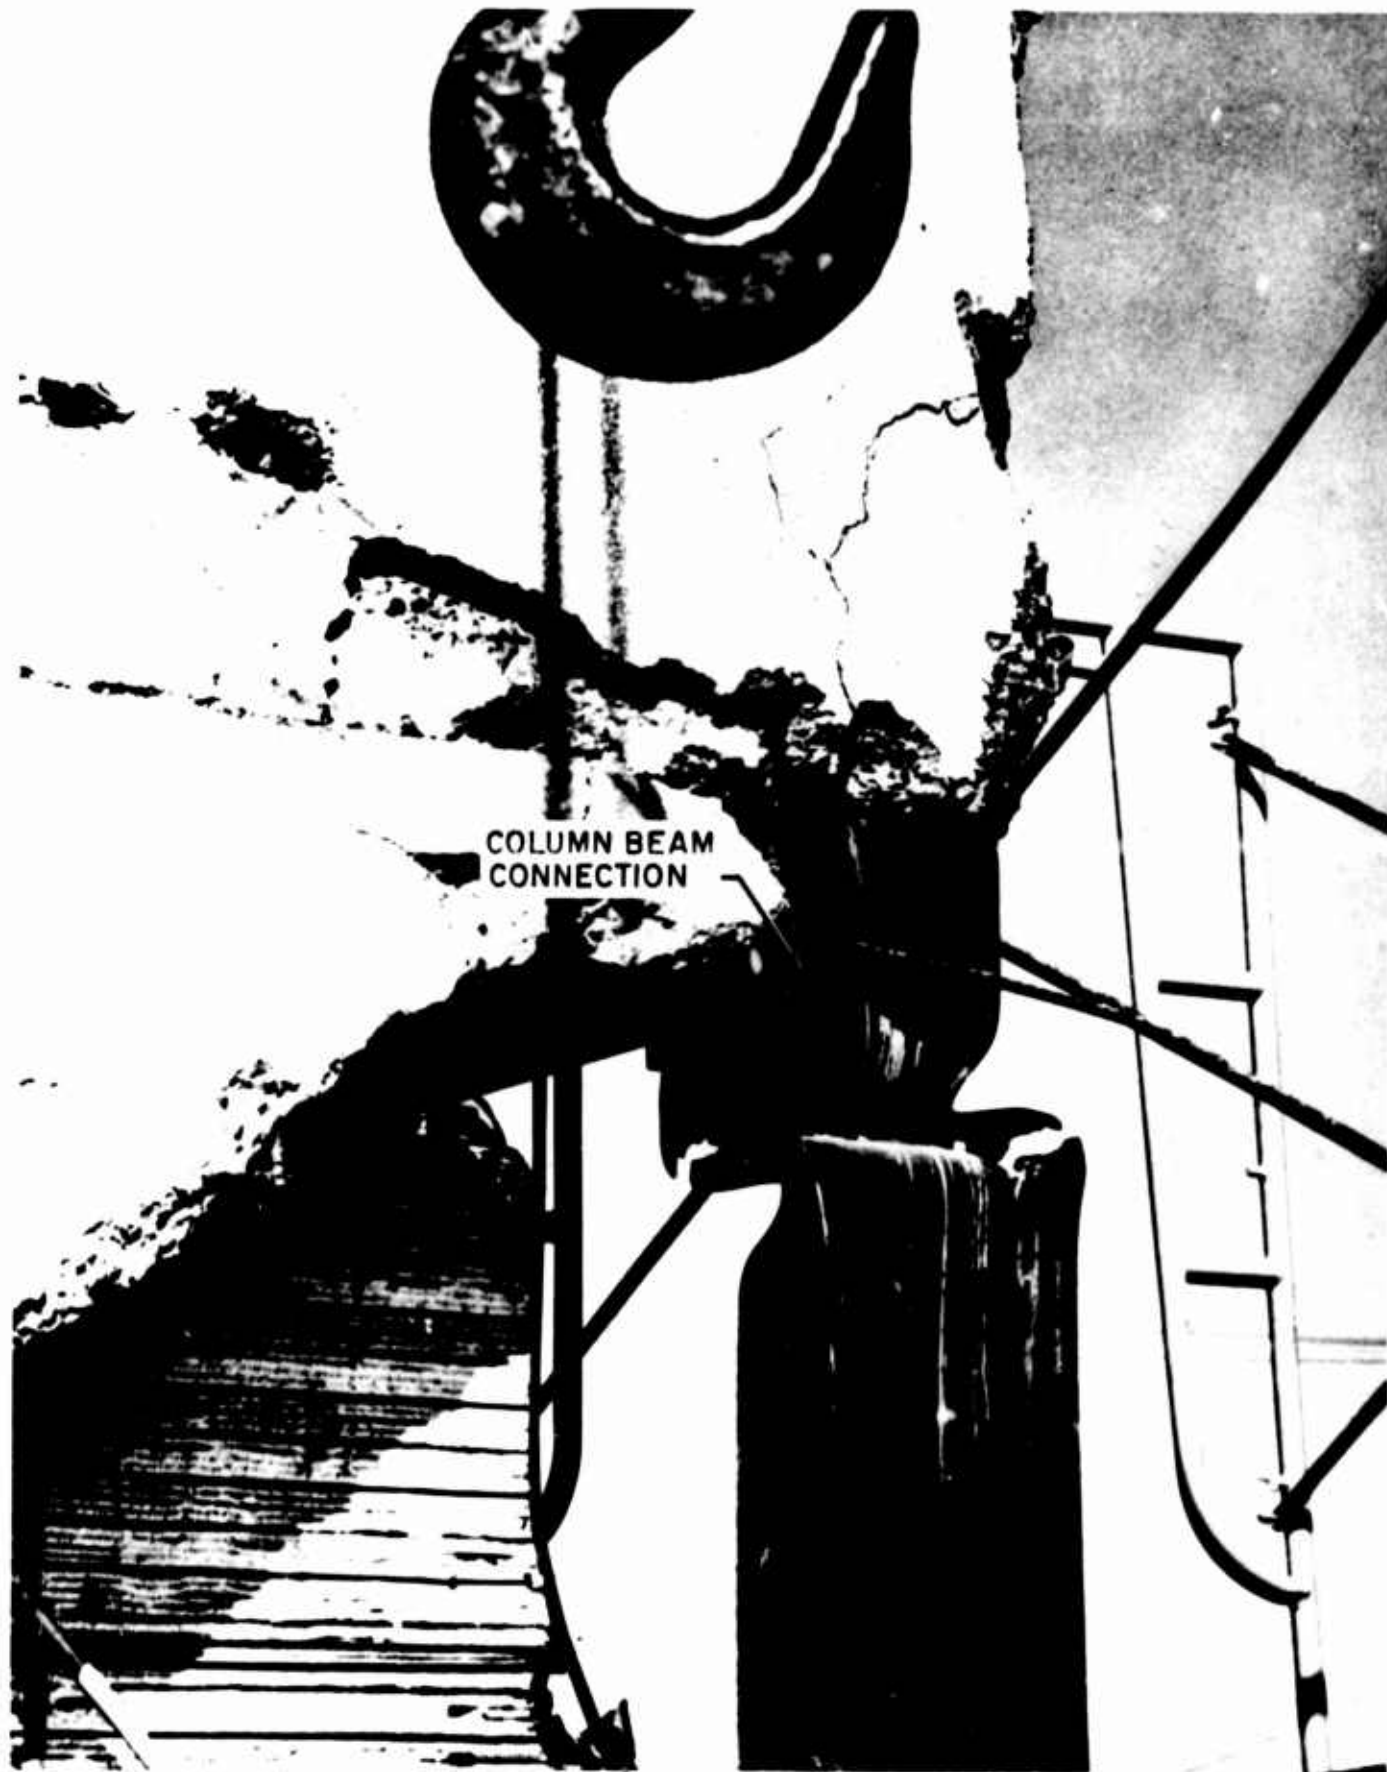
Figure 219. Cordova Building
(Shear buckle in southeast corner column of building)

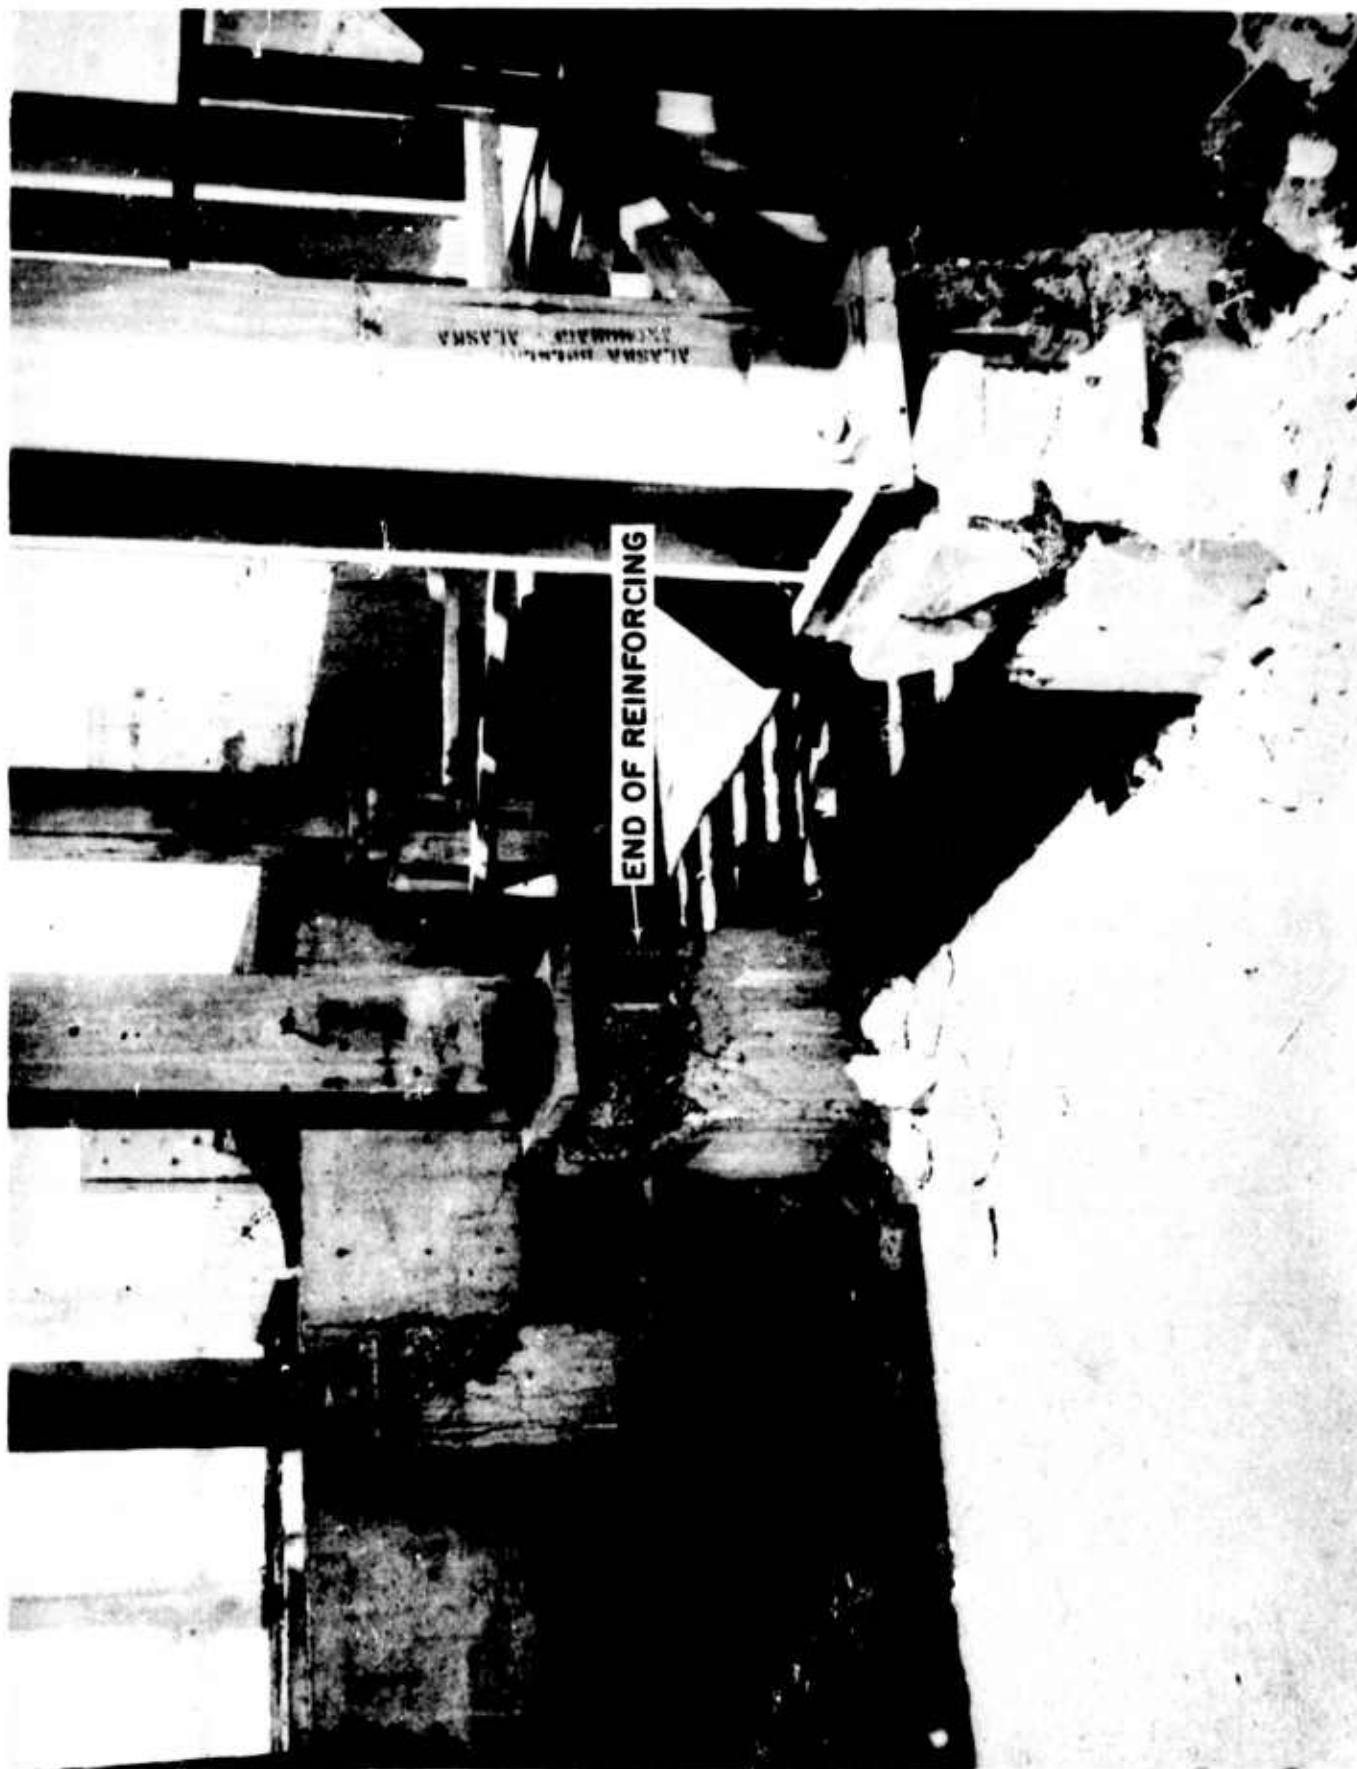
Figure 223. Alaska Brewery Company Structure
(Typical damage to interior footing due to pounding by steel columns)

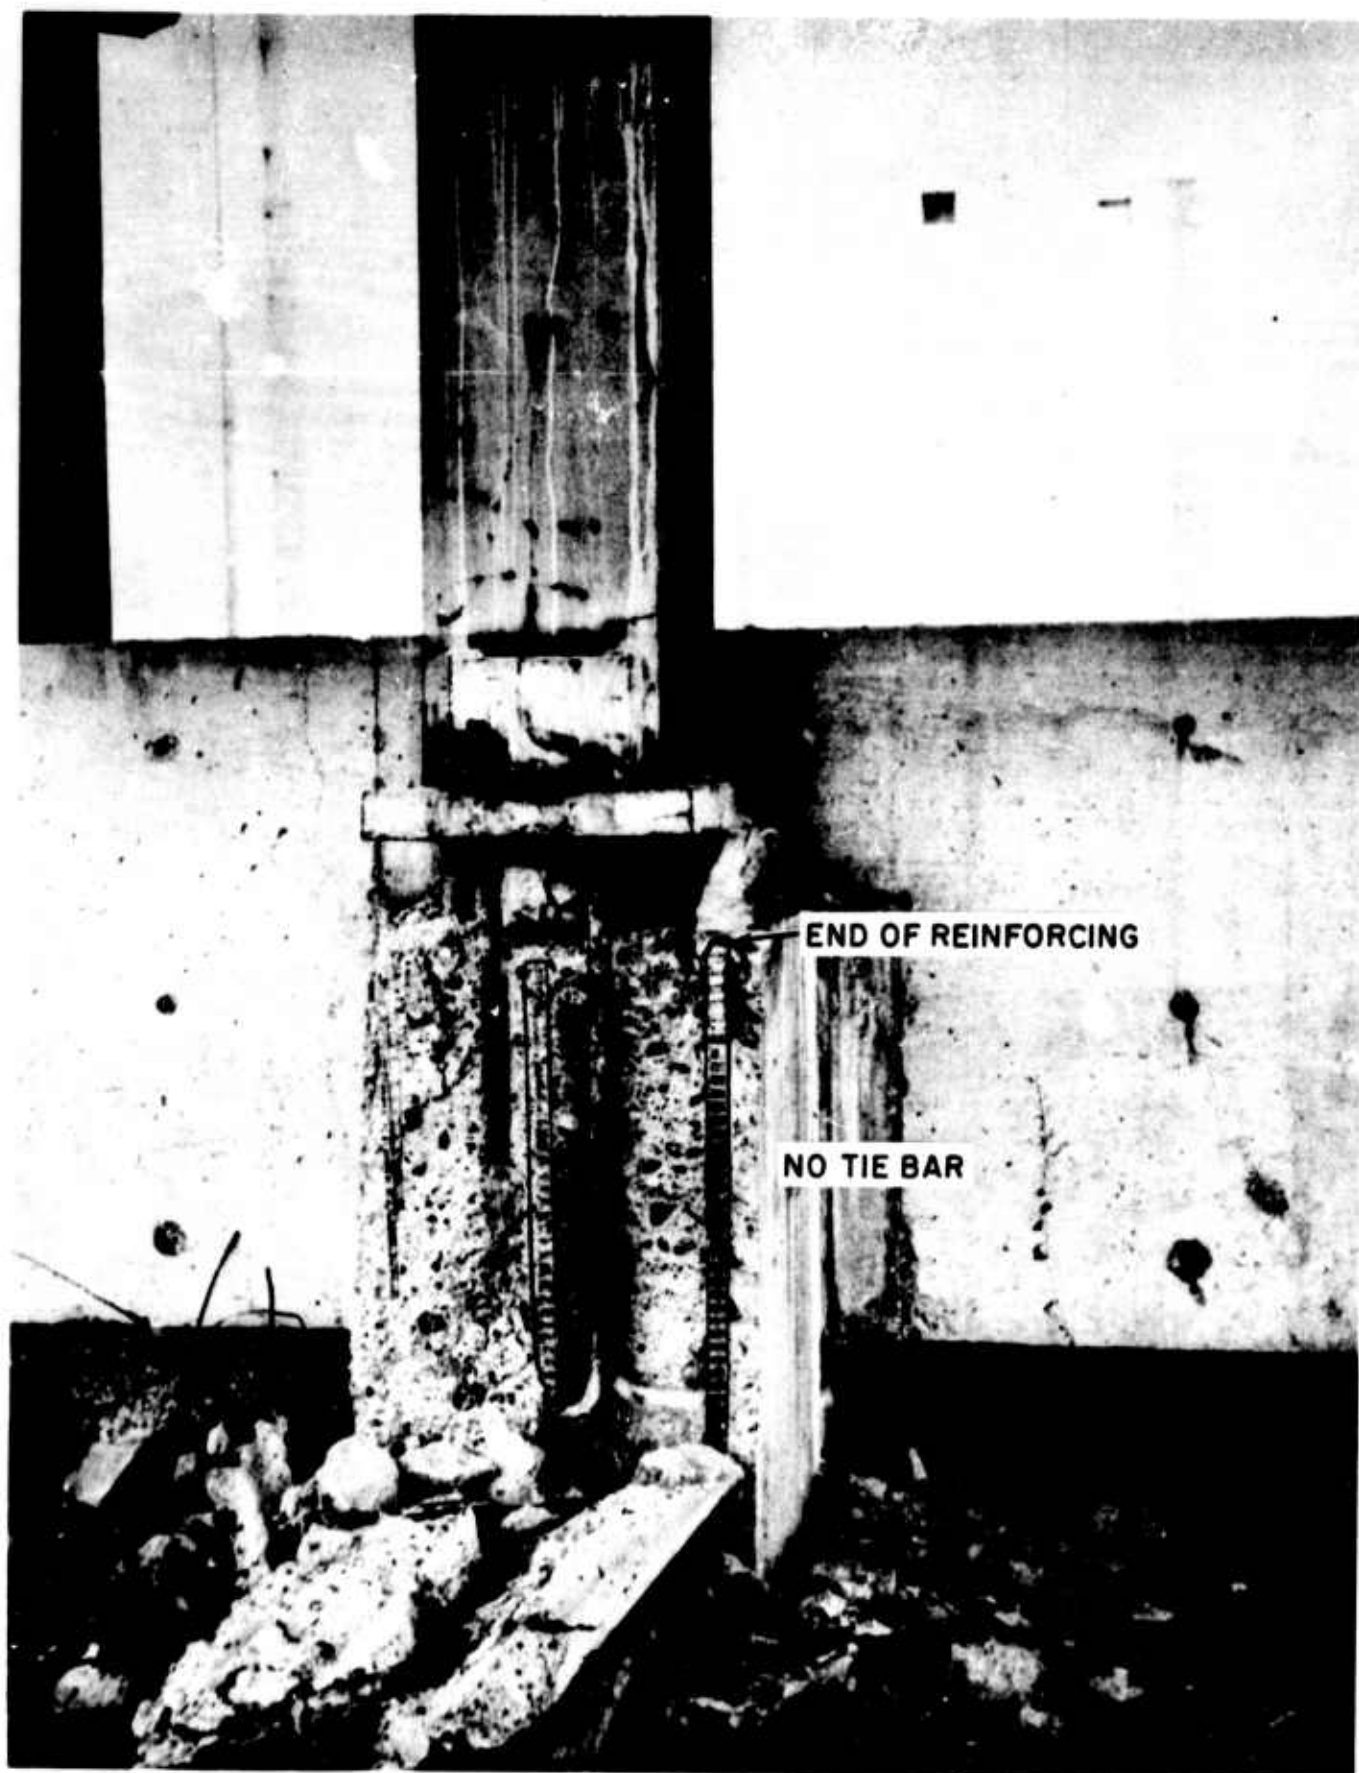
Figure 226. Alaska Brewery Company Structure
(Severe damage to an exterior footing without horizontal ties)
